Manhole Inspection Summary

Manhole # S47K__012MH

Insp Date: **7/28/08 2:15 PM**

Location Address: **2228 cambridge st**

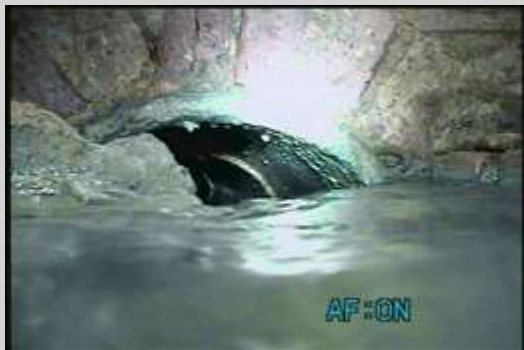
12 O'Clock Outflow

12 in. Circular Gravity Sewer
Pipe Out @ 12 O'Clock

Pipe Material: Clay ☐ Pipe Lined

Invert Depth: 10.30 (ft.) Flow Characteristics: Fast

Deposits: ☒ None ☐ Mud ☐ Sludge ☐ Debris ☐ Grease

Infiltration: None Pipe Seal Cond: Unknown

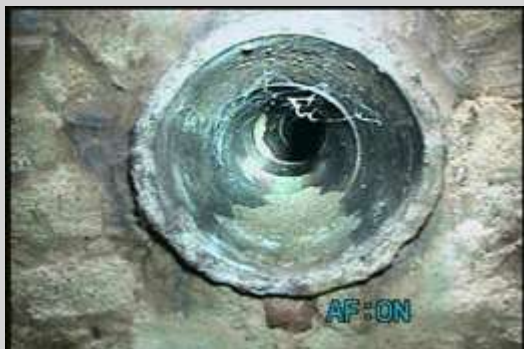
3 O'Clock Inflow

8 in. Circular Gravity Sewer
Pipe In @ 3 O'Clock

Pipe Material: Clay ☐ Pipe Lined

Invert Depth: 8.11 (ft.) Flow Characteristics: None

Deposits: ☒ None ☐ Mud ☐ Sludge ☐ Debris ☐ Grease

Infiltration: None Pipe Seal Cond: Unknown

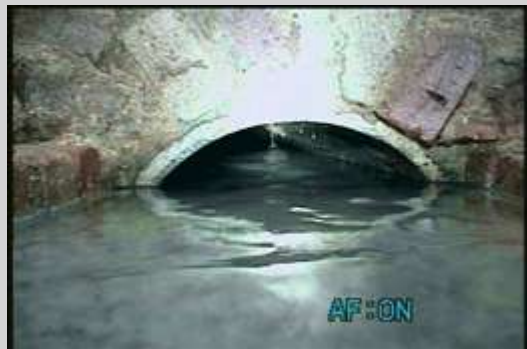
6 O'Clock Inflow

12 in. Circular Gravity Sewer
Pipe In @ 6 O'Clock

Pipe Material: **Clay** ☐ Pipe Lined

Infiltration: **None** Pipe Seal Cond: **Unknown**
